11 West Street

Introduction

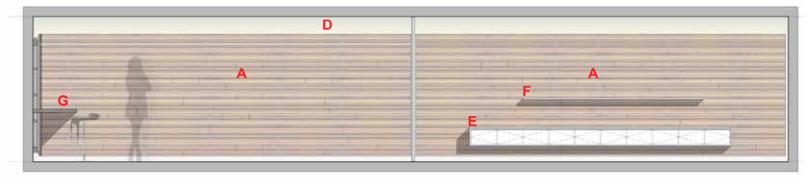
ELEVATION 01

- C = Lacquered (2 coat) MDF flush panel joinery (on push release) colour to match wall
- **D** = Concealed uplighting washing light over upper painted plasterboard wall
- **E** = Wall hung lacquered (2 coat) MDF credenza unit (white)
- **F** = Concealed fixed lacquered (2 coat) MDF shelf unit (white)
- **G** = Concealed fixed lacquered (2 coat) MDF bar/bench unit (white)
- H = Oak timber floor boards (secret nailed) smoked and naturally oiled
- **J** = Broadloom carpet (final selection TBA) Note: Furniture selection by client

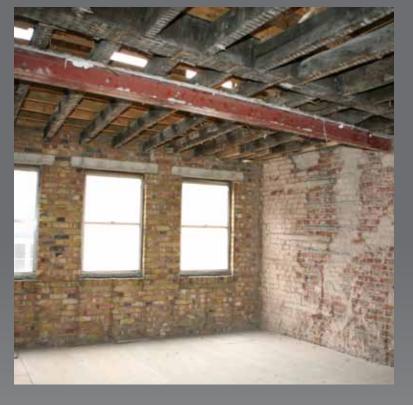
Enabling works

To enable the works to be undertaken a temporary gantry was constructed, capable of supporting scaffolding together with a temporary roof structure. The structural steel temporary gantry was supported by pad stone foundations excavated through the existing pavement outside the building sited in the sub-floor of the basement area. Due to restrictions in place for the service road at the front, these works were completed out of hours utilising specialist lifting equipment to avoid the use of heavy crane.

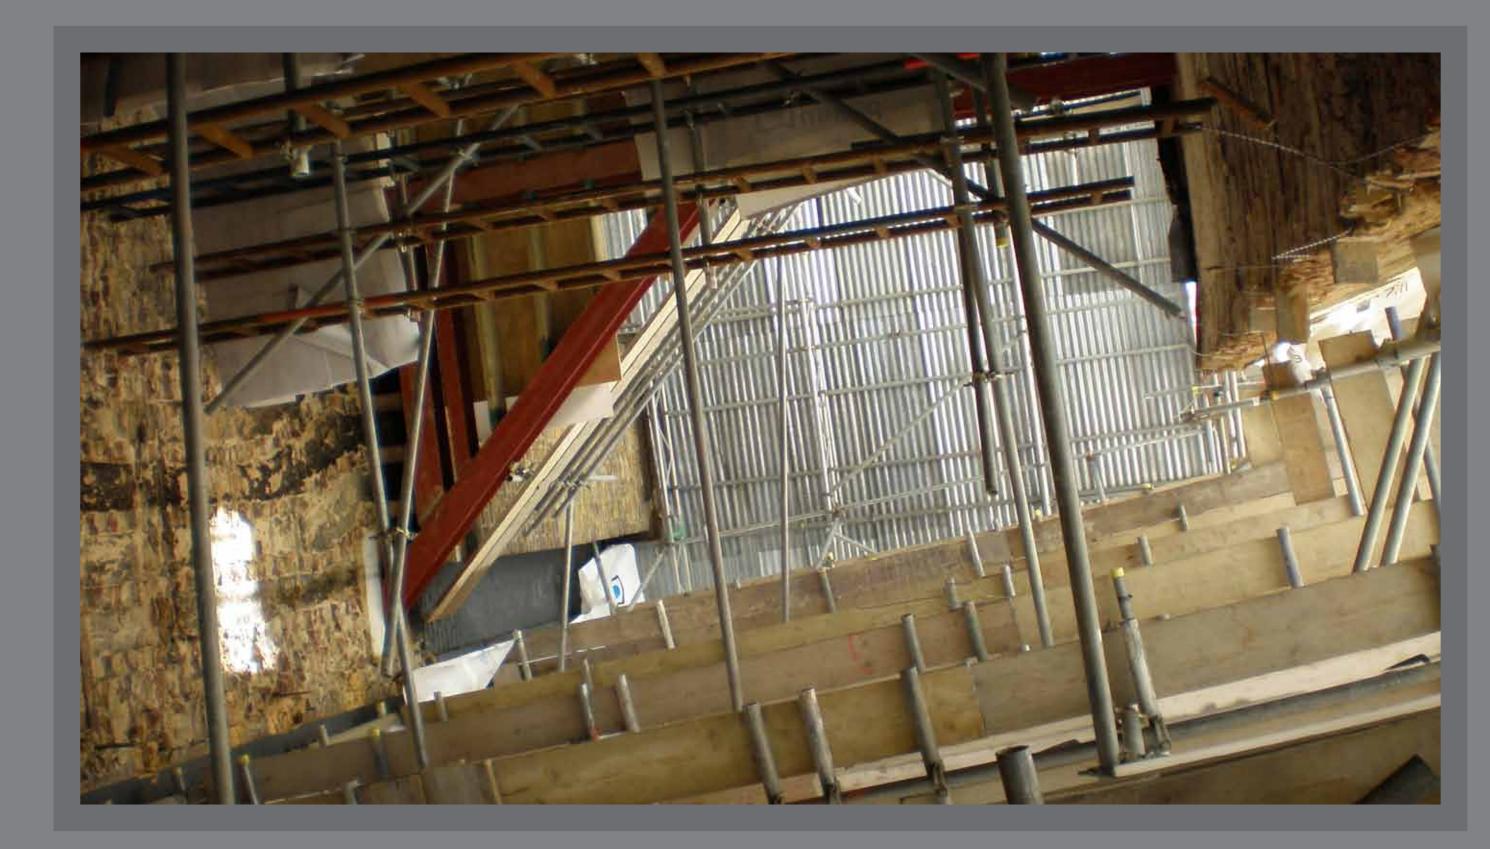
Demolition followed on a floor by floor basis deconstructing each section whilst supporting the party walls to either side of the building. Whilst these works were in progress the existing staircase and rear elevation were adapted in-situ to take into account the new floor plan.

Each floor was reinstated with structural sectional steel floor joists, spliced and bolted together using specialist assembly techniques to avoid traditional lifting methods due to the restricted working space.

The existing party walls were surveyed and repaired to remove existing structural defects to neighbouring buildings. This necessitated underpinning at basement level.

Once the new structure was completed to ground floor level the existing brick façade was taken down floor by floor whilst we supported the neighbouring buildings at all levels.

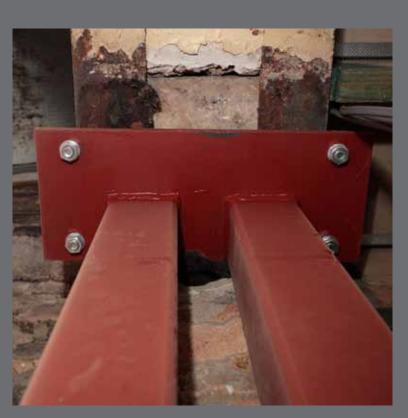
The next phase involved excavating the existing basement by hand. This required complex propping to be put in place. The finished work provided a larger basement footprint to accommodate the new boardroom. Once excavation was complete we removed the existing pavement together with the decayed pavement lights at street level. The basement was then encased in a modern damp proof system to allow the occupation of previously unusable space.

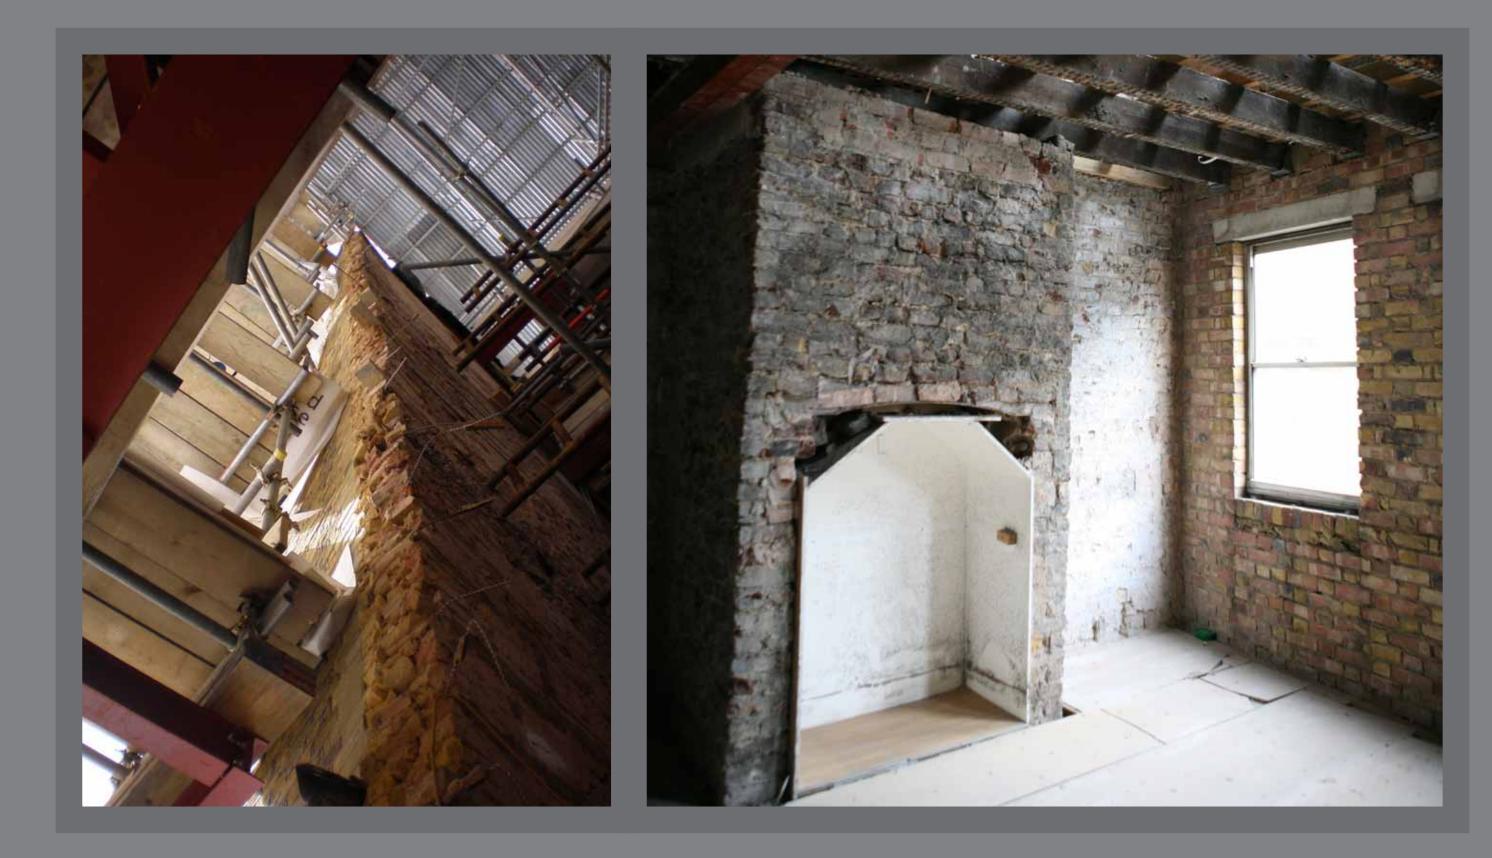
Re-construction

The front section of the building is supported on an in-situ concrete reinforced steel frame set out between the party walls of the neighbouring buildings. With the new supporting steel structure in place we rebuilt the front façade and tied it into neighbouring buildings on a floor by floor basis. This allowed sectional completion of the subfloors from the bottom approach to roof level. The unique top down, not bottom up construction technique allowed continuity of the build process whilst taking into account the complex engineering requirements. This created more flexibility and continuity in the project programme.

Salvaged ships timbers were taken away from site to be drilled, planked and transformed into the board room panelling in the basement of the building.

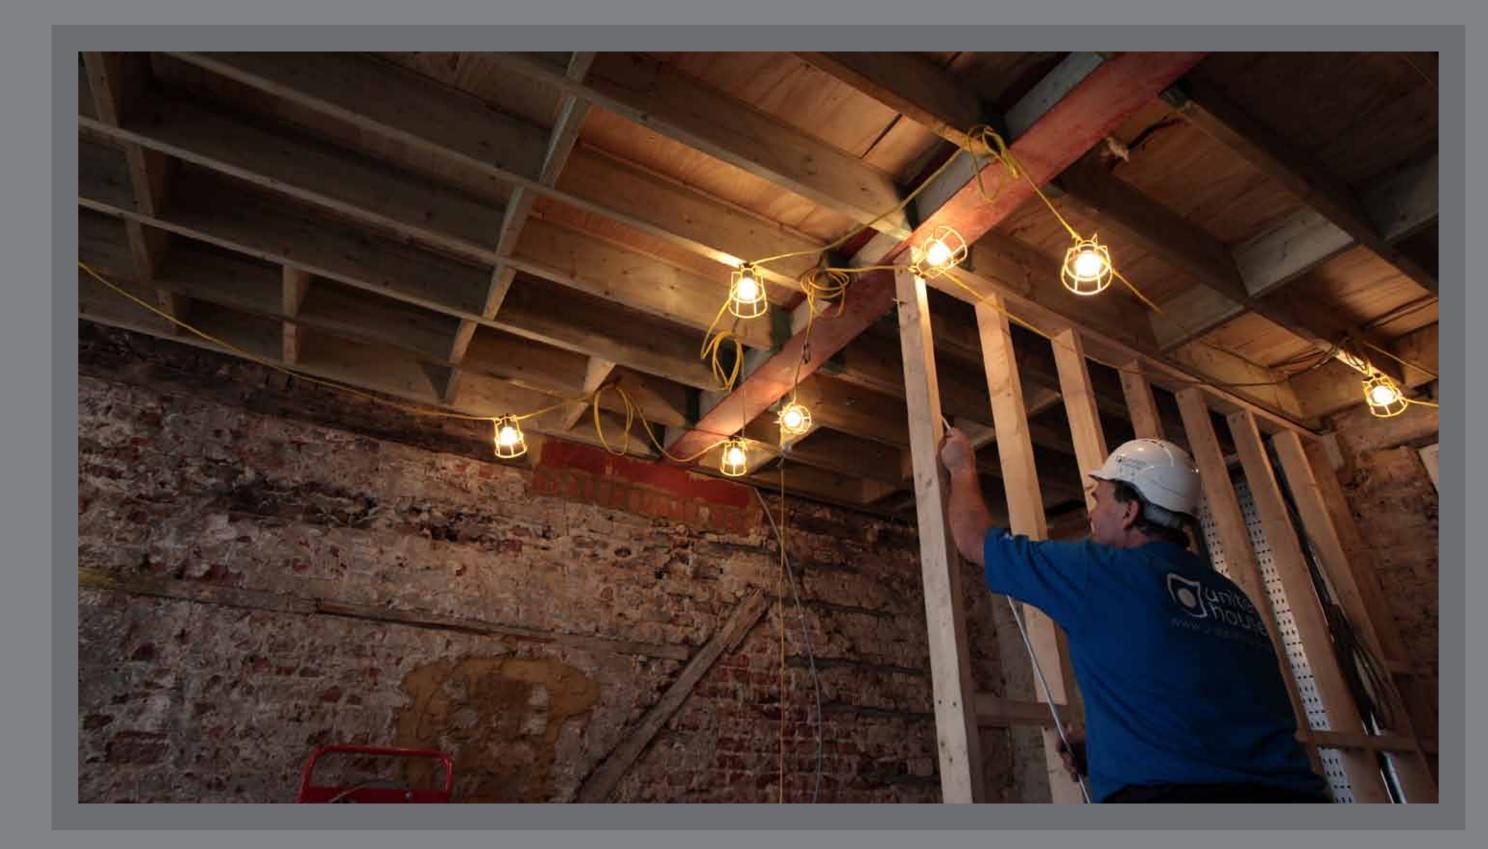
Finishing works

With the new structure in place each floor was designed to the highest standards with a plasterboard skim finish, timber sub-floor with acoustic boarding, high performance high quality timber double glazed windows, oak joinery, together with oak flooring. Particular attention was paid to the ecological and sustainable ethos of the company.

Through wall insulation, sustainably resourced materials, high quality internal finishes were all a feature of the quality plan for the project.

The existing staircase was adapted, introducing bespoke floor to ceiling glazing scribed and lined oak joinery.

The reception entrance to the front of the building features the installation of a structural glass floor to enable light to the boardroom in the basement. This also has a modern lighting system allowing wash colours to light both the reception area and the boardroom. Feature glass panelling was installed etched with the United House symbol to provide a personalised identity to the building.
